SERVICE BULLETIN

2002 Q45; TRANSMISSION MANUAL MODE INOPERATIVE (DTC P1815-MANU MODE S/W/CIRC)

APPLIED VEHICLE(S): 2002 Q45 (F50)

TRANSMISSION CONTROL MODULE (TCM) REPROGRAMMING

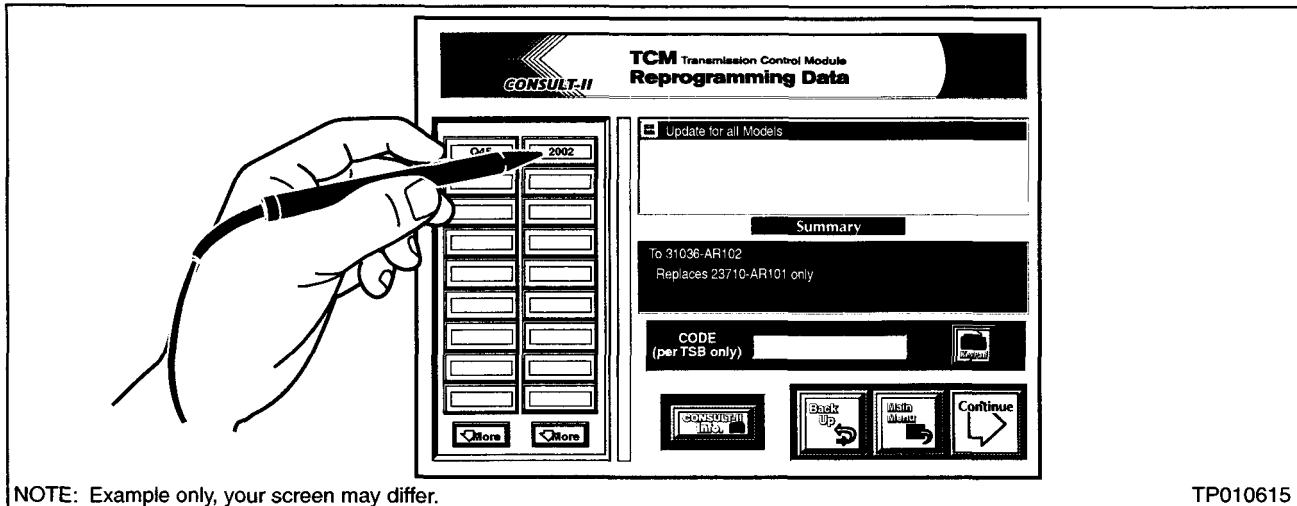
Figure 1

- If your ASIST terminal has not been used to perform ECU reprogramming before: Go to ASIST and refer to "**CONSULT-II Info**" under CONSULT Utilities to set it up for "Ethernet" communication.
 - If your ASIST terminal has been used to perform ECU re-programming before, proceed to step 5.
5. Launch ASIST. From the ASIST PC main menu screen, select "**CONSULT Utilities**".
6. From the "**CONSULT Utilities**" screen, select "**TCM Data**".
7. The "**TCM Data Reprogramming**" screen will be displayed (see Figure 1):

- A. Select model and model year for the applied vehicle.
- B. Select the applicable vehicle configuration for your vehicle from that listed in the upper right TCM data description window.
- If there is only one item listed, go to step C.
- If multiple selections are listed, select the applicable vehicle configuration then go to step C.
- C. Click the "**Continue**" button on the TCM Data Reprogramming screen to proceed to CONSULT-II setup.

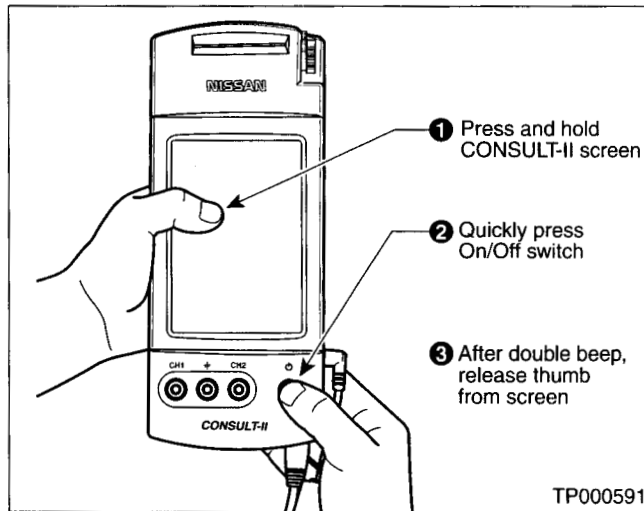
8. Turn on CONSULT-II as follows to access the file transfer mode:
- A. While pressing on the CONSULT-II screen with your thumb, quickly depress and release the ON/OFF switch (see Figure 2).

Release your thumb from the screen after a double-beep sound is heard.

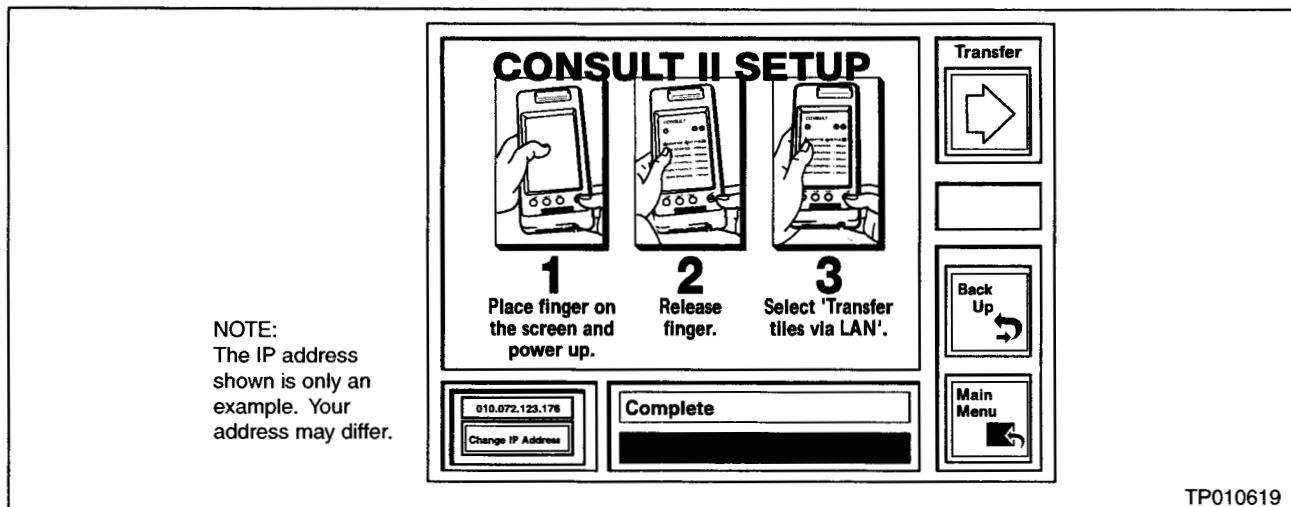
Figure 3

10. Data transfer will take about 1 minute and the progress of the transfer is displayed on the ASIST PC screen (see Figure 3). Wait until the data transfer is complete (see **CAUTION**, below).

CAUTION: DO NOT DISCONNECT THE ETHERNET CABLE UNTIL "COMPLETE" IS DISPLAYED AS SHOWN IN FIGURE 3. If the cable is disconnected before **"Complete"** is displayed you **MUST** restart the download procedure. Otherwise TCM damage can occur.

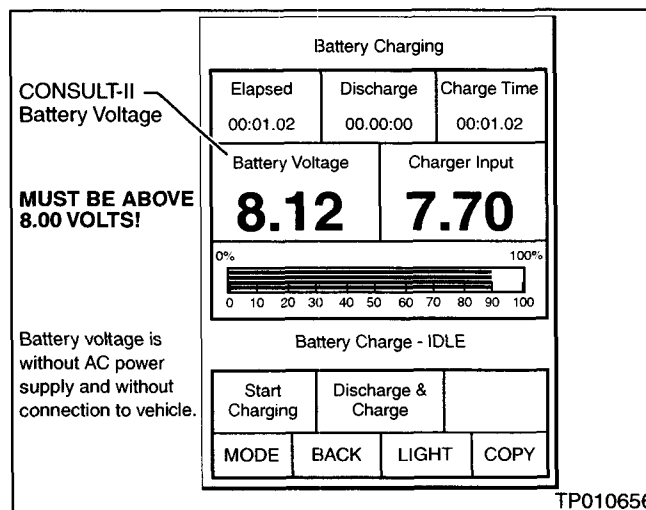
Figure 4

26. After about one minute has passed, check the CONSULT-II's battery voltage reading on the CONSULT-II screen (see Figure 4).

NOTE: CONSULT-II's battery voltage is called **"BATTERY VOLTAGE"**.

A. If CONSULT-II's battery voltage ("Battery Voltage") is less than 8 volts:

B. If CONSULT-II's battery voltage ("Battery Voltage") is more than 8 volts, proceed with the following step.

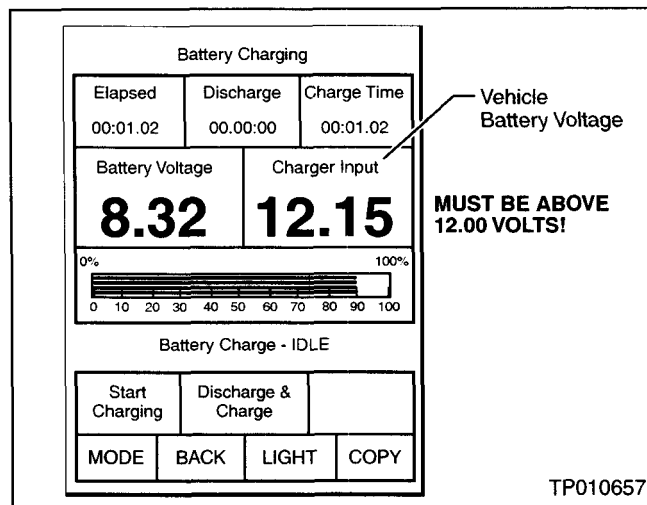
Figure 5

27. Connect CONSULT-II to the vehicle making sure the connector is fully plugged in.
28. Turn the ignition switch **ON** (DO NOT start the vehicle).
29. After about one minute has passed, check the vehicle's battery voltage reading on the CONSULT-II screen (see Figure 5).

NOTE: The vehicle's battery voltage is called "Charger Input".

- A. If the vehicle's battery charge ("Charger Input") is less than 12.0 volts:
 - Press "**BACK**" (2x) to go back to the main menu
 - Charge the battery properly/replace it before proceeding with TCM Reprogramming

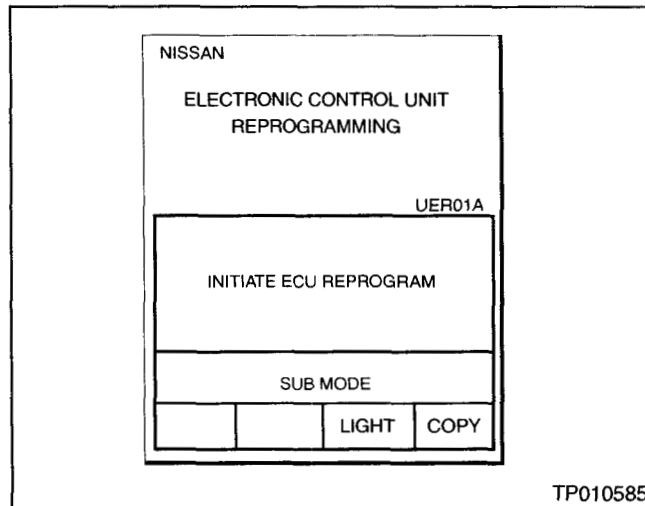
Figure 6

32. **Make sure the DLC-II cable is firmly plugged into the vehicle harness** (see **CAUTION** below). Turn "**ON**" the ignition switch (do not start the engine). CONSULT-II will turn on automatically (see Figure 6).

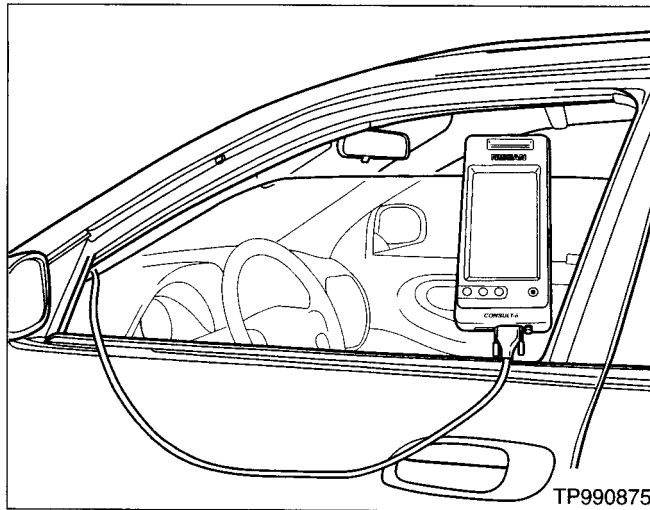
Figure 7

35. Roll down the driver's window part way, exit the vehicle, close the door and hang the CONSULT-II unit on the outside of the window (see Figure 7).

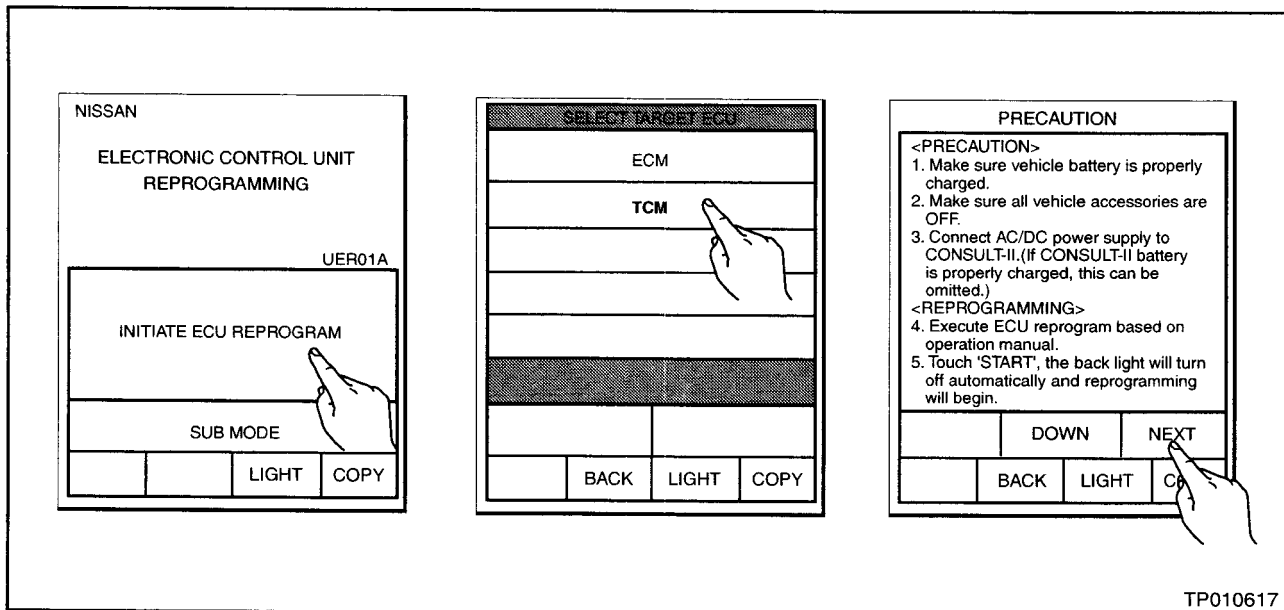
Figure 8

36. Press “Initiate ECU Reprogram” (see Figure 8), then do the following:

- Press “TCM”
- Review the precaution
- Press “Next”

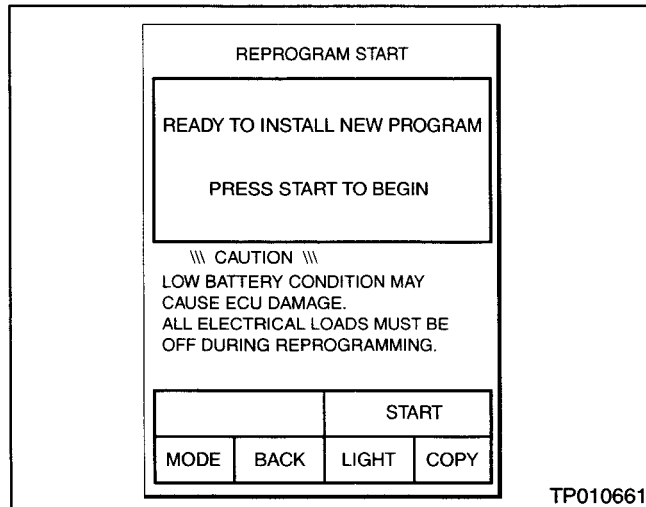
Figure 11

41. The "REPROGRAM START" window should appear (see Figure 11).

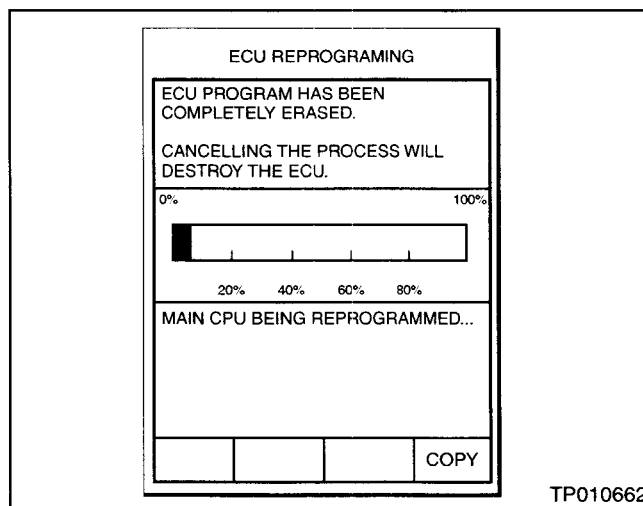
42. Press "**START**". After a moment the window shown in Figure 12 will appear. CONSULT-II will now turn off its screen backlight and reprogram the TCM.

When the Reprogramming is complete, CONSULT-II will "beep", turn the screen backlight back on and automatically print out a report.

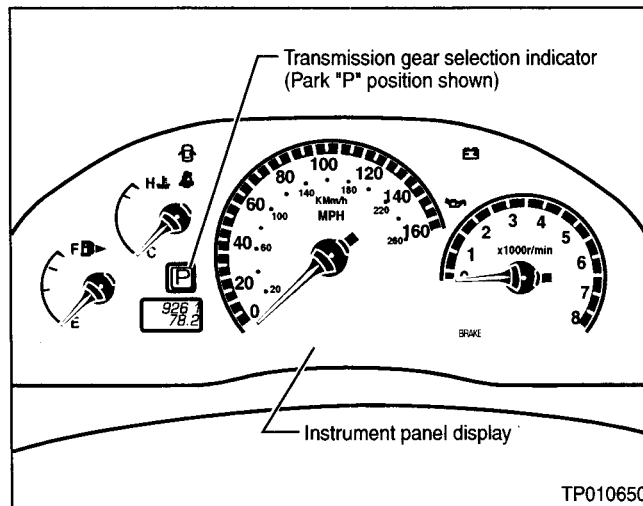
Figure 14

NOTE: During the next step you need to determine how long it takes for the "**P**" indicator (see Figure 14) to illuminate after the ignition key is turned to the **ON** position. It will either take one second or three seconds.

55. Release the brake pedal, watch the A/T gear selection indicator on the instrument panel display, and turn the ignition key to the **ON** position.

61. Depress the brake pedal and move the shift lever from “**P**” to “**R**” to “**N**” to “**D**”, making sure the indicator next to the speedometer (see Figure 14) correctly displays each selected shift lever position.

62. Move the shift lever back from “**D**” to “**N**” to “**R**” to “**P**”, making sure the indicator next to the speedometer (see Figure 14) correctly displays each selected shift lever position.

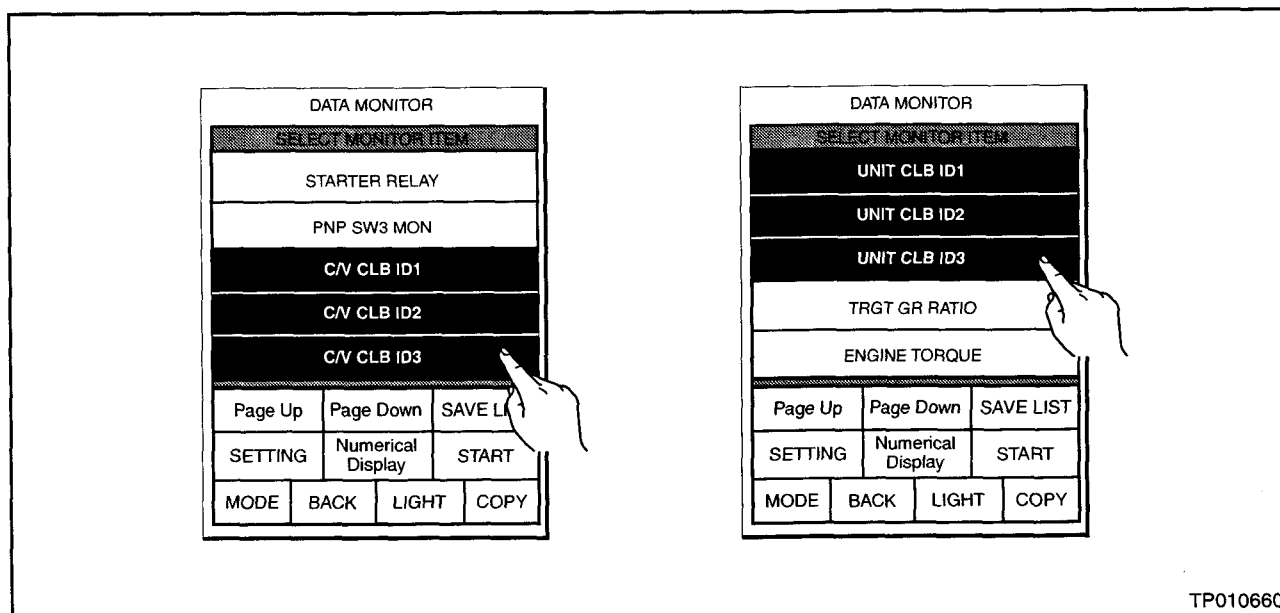
Figure 15

57. Scroll down and select the following items (see Figure 15):

- C/V CLB ID1
- C/V CLB ID2
- C/V CLB ID3
- UNIT CLB ID1
- UNIT CLB ID2
- UNIT CLB ID3

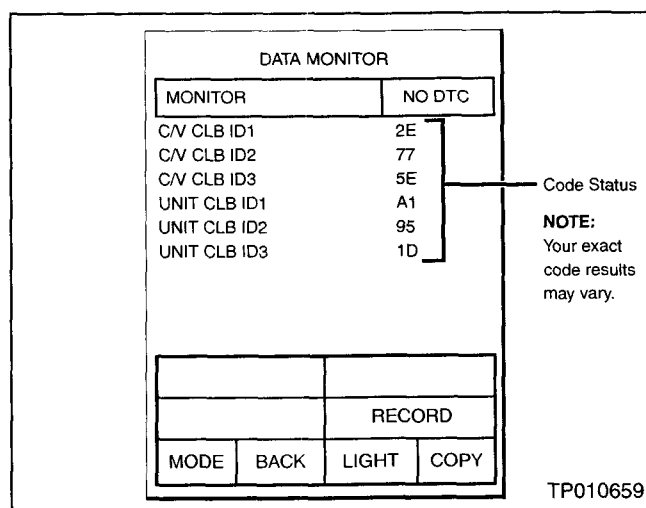
Figure 16

59. Confirm the status of the codes (see Figure 16):

- If **ALL** the codes (i.e., the codes listed in step 57) have a code status of "00" or "FF", press **BACK (3x)**, then go back to step 49 and start over from the second bullet point.
- If "00" or "FF" **DO NOT** appear, proceed with step 60.
